Manhole Inspection Summary

Manhole # S15AA_009MH

Insp Date: **5/6/09 1:49 PM**

Location Address: **REAR 2625 LAFAYETTE**

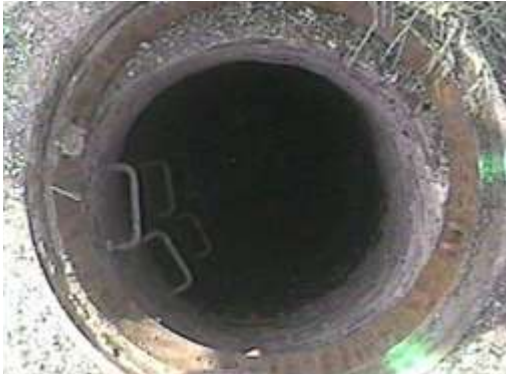
Defect 1

Frame Offset: **3** (in.) Condition: ☒ Sound ☐ Cracked ☐ Leaks

FRAME OFFSET

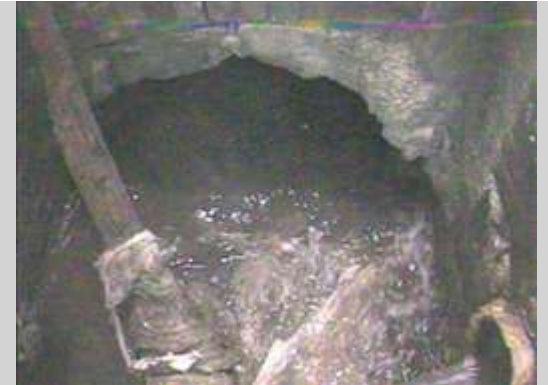
12 O'Clock Outflow

42 in. Circular Gravity Sewer
Pipe Out @ 12 O'Clock

Pipe Height: **43.2** (in.) Rod and Bar (Angled)
Pipe Material: **Unknown** ☐ Pipe Lined
Invert Depth: **24.90** (ft.) Flow Characteristics: **Fast**
Deposits: ☐ None ☐ Mud ☒ Sludge ☒ Debris ☒ Grease
Silt Depth: **3** (in.) Deposits Extent: **Light**
Infiltration: **None** Pipe Seal Cond: **Unknown**

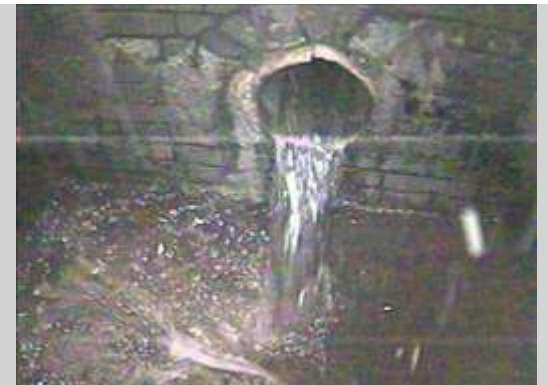
3 O'Clock Inflow

12 in. Circular Gravity Sewer
Pipe In @ 3 O'Clock

Pipe Height: **12** (in.) Rod and Bar (Angled)
Pipe Material: **Clay** ☐ Pipe Lined
Invert Depth: **22.06** (ft.) Flow Characteristics: **Fast**
Deposits: ☒ None ☐ Mud ☐ Sludge ☐ Debris ☐ Grease
Silt Depth: (in.) Deposits Extent:
Infiltration: **None** Pipe Seal Cond: **Cracked**

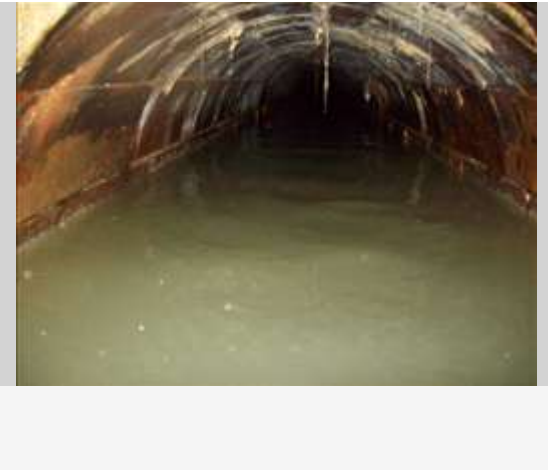
6 O'Clock Inflow

33 in. Circular Gravity Sewer
Pipe In @ 6 O'Clock

Infiltration: **None** Pipe Seal Cond: **Cracked**
